**Subject: ER-Bedford Anodizing Tanks and Vats
Macedonia, Summit County, Ohio
Technical Direction Document No.: S05-000-1308-003
Document Control No.: 2233-2A-BIZR
WESTON START Contract No.: EP-S5-06-04
Work Order No: 20405.012.001.2233.00**

Bedford Anodizing Site Assessment
April 18, 2014

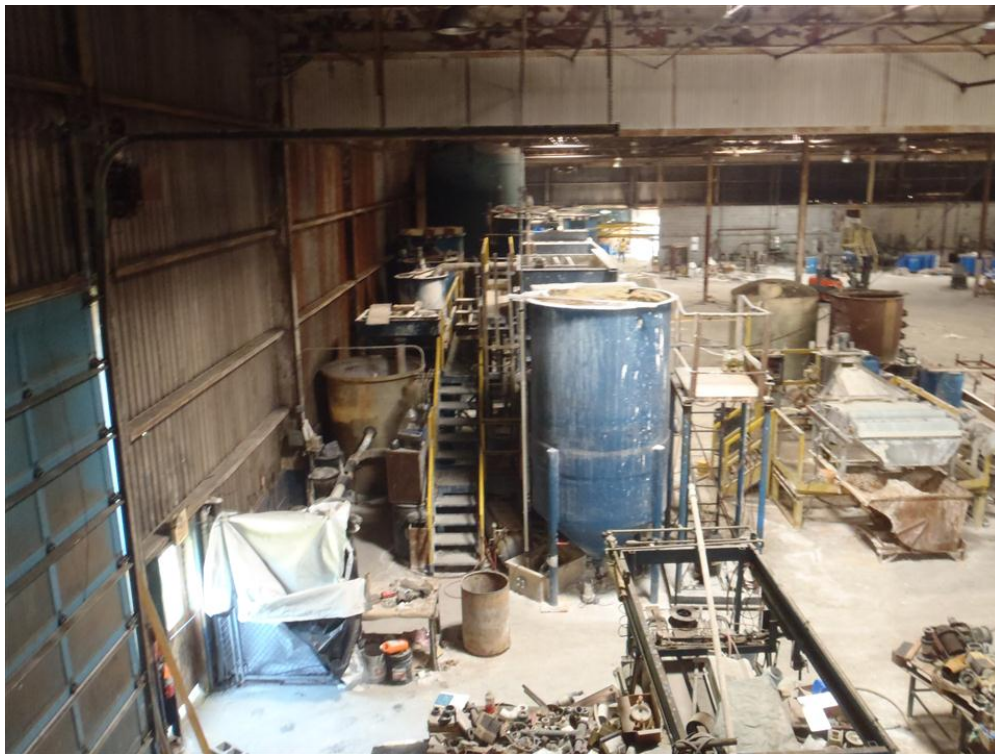
Site: ER-Bedford Anodizing Tanks and Vats
Photograph No.: 2
Direction: East
Subject: Wastewater treatment area containing 21 tanks

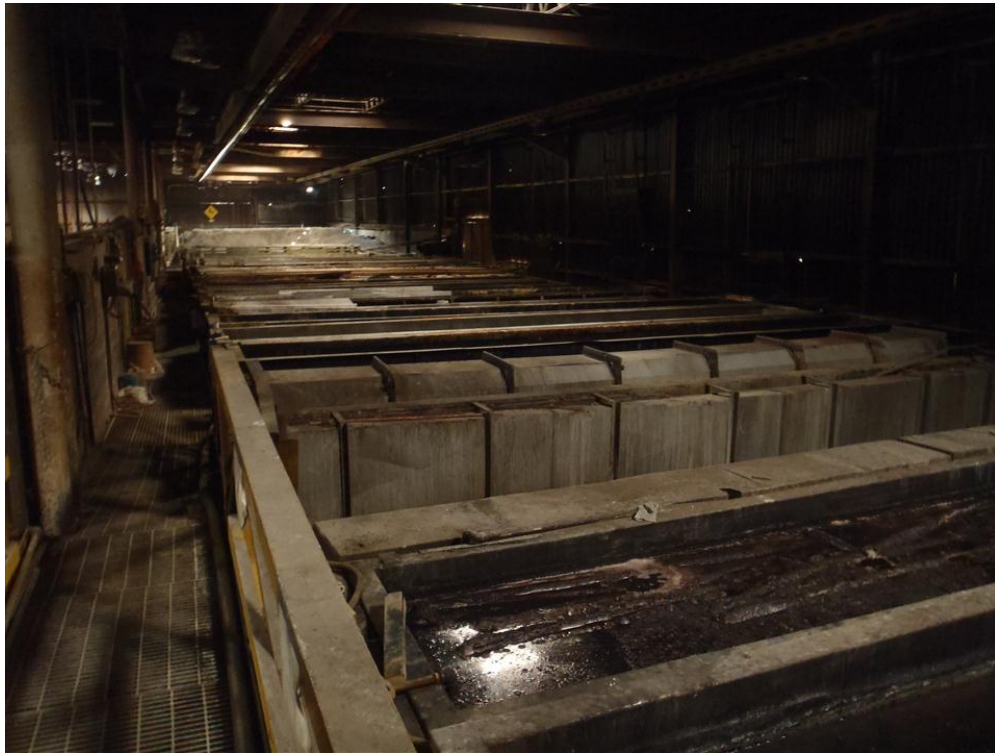
Site: ER-Bedford Anodizing Tanks and Vats
Photograph No.: 3
Direction: North
Subject: Main anodizing line containing 30 vats

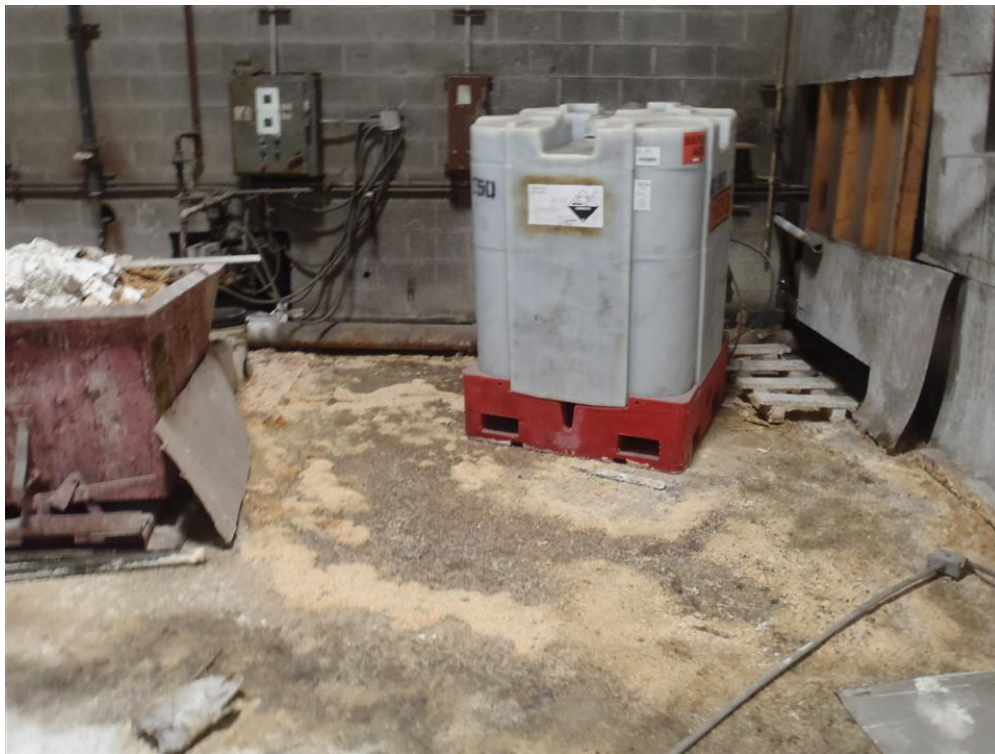
Site: ER-Bedford Anodizing Tanks and Vats
Photograph No.: 4
Direction: East
Subject: Spilled material on the floor near a tote labeled sulfuric acid, corrosive
